# CASE STUDY 🏓

# LIFT STATION REPAIRS DEMONSTRATE EFFICACY OF NEW CHEMICAL GROUT INJECTION TECHNOLOGY

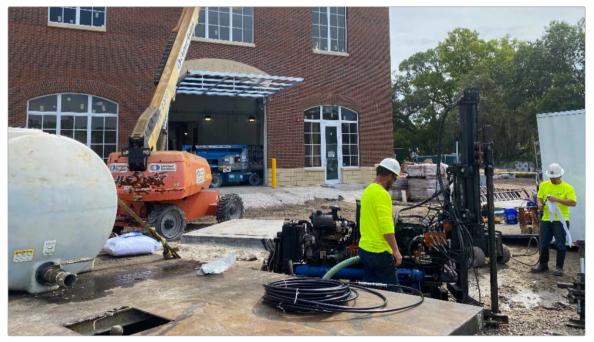
Sealing the buried line while construction continues uninterrupted on the remainder of the lift station infrastructure by the prime contractor.

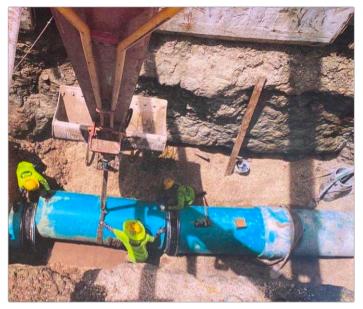
Lift Station 87 subject pipe during original installation

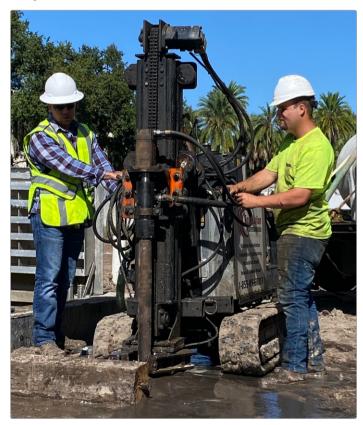
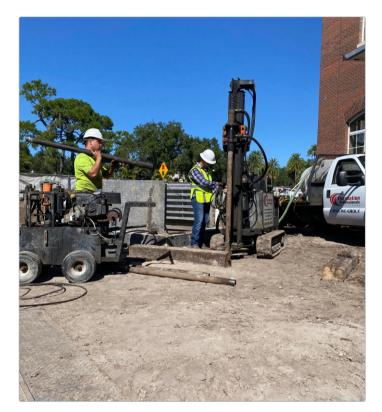
The DHIG rig is used, in part, to advance injection casing to the desired depth. The three-inch diameter steel casing, threaded on each end, is advanced, with new sections threaded on as needed. While skin friction is considered negligible, it takes increasing power to turn the casing as it advances more deeply. Turning power is also affected by the strength and adhesive properties of the material being advanced through the casing.

Upon reaching the desired injection depth, the rig withdraws the casing as the polymer is injected. Care must be used to advance at an appropriate rate that avoids fouling the casing with the polymer; but not so fast that the polymer is under-injected. To inject the polymer, a special nozzle is advanced through the casing and attached to the drilling head at the tip of the casing. This is the third use of the rig, to lower the casing head and attached chemical feed lines in a careful manner, to avoid fouling the lines or damaging the injection nozzle. Upon carefully lowering the equipment by attaching a lowering/turning bar, that bar is then rotated to lock the equipment to the head. As the casing is withdrawn, the lowering bar is removed in sections, just as the casing is removed.
